Interim Report on Wakayama Refinery Fires Issued by Incident Investigation Committee

Report on Investigation Regarding Causes of the Fires at the Wakayama Refinery

(Interim Report Summary)

February 28, 2017
TonenGeneral Sekiyu K.K.

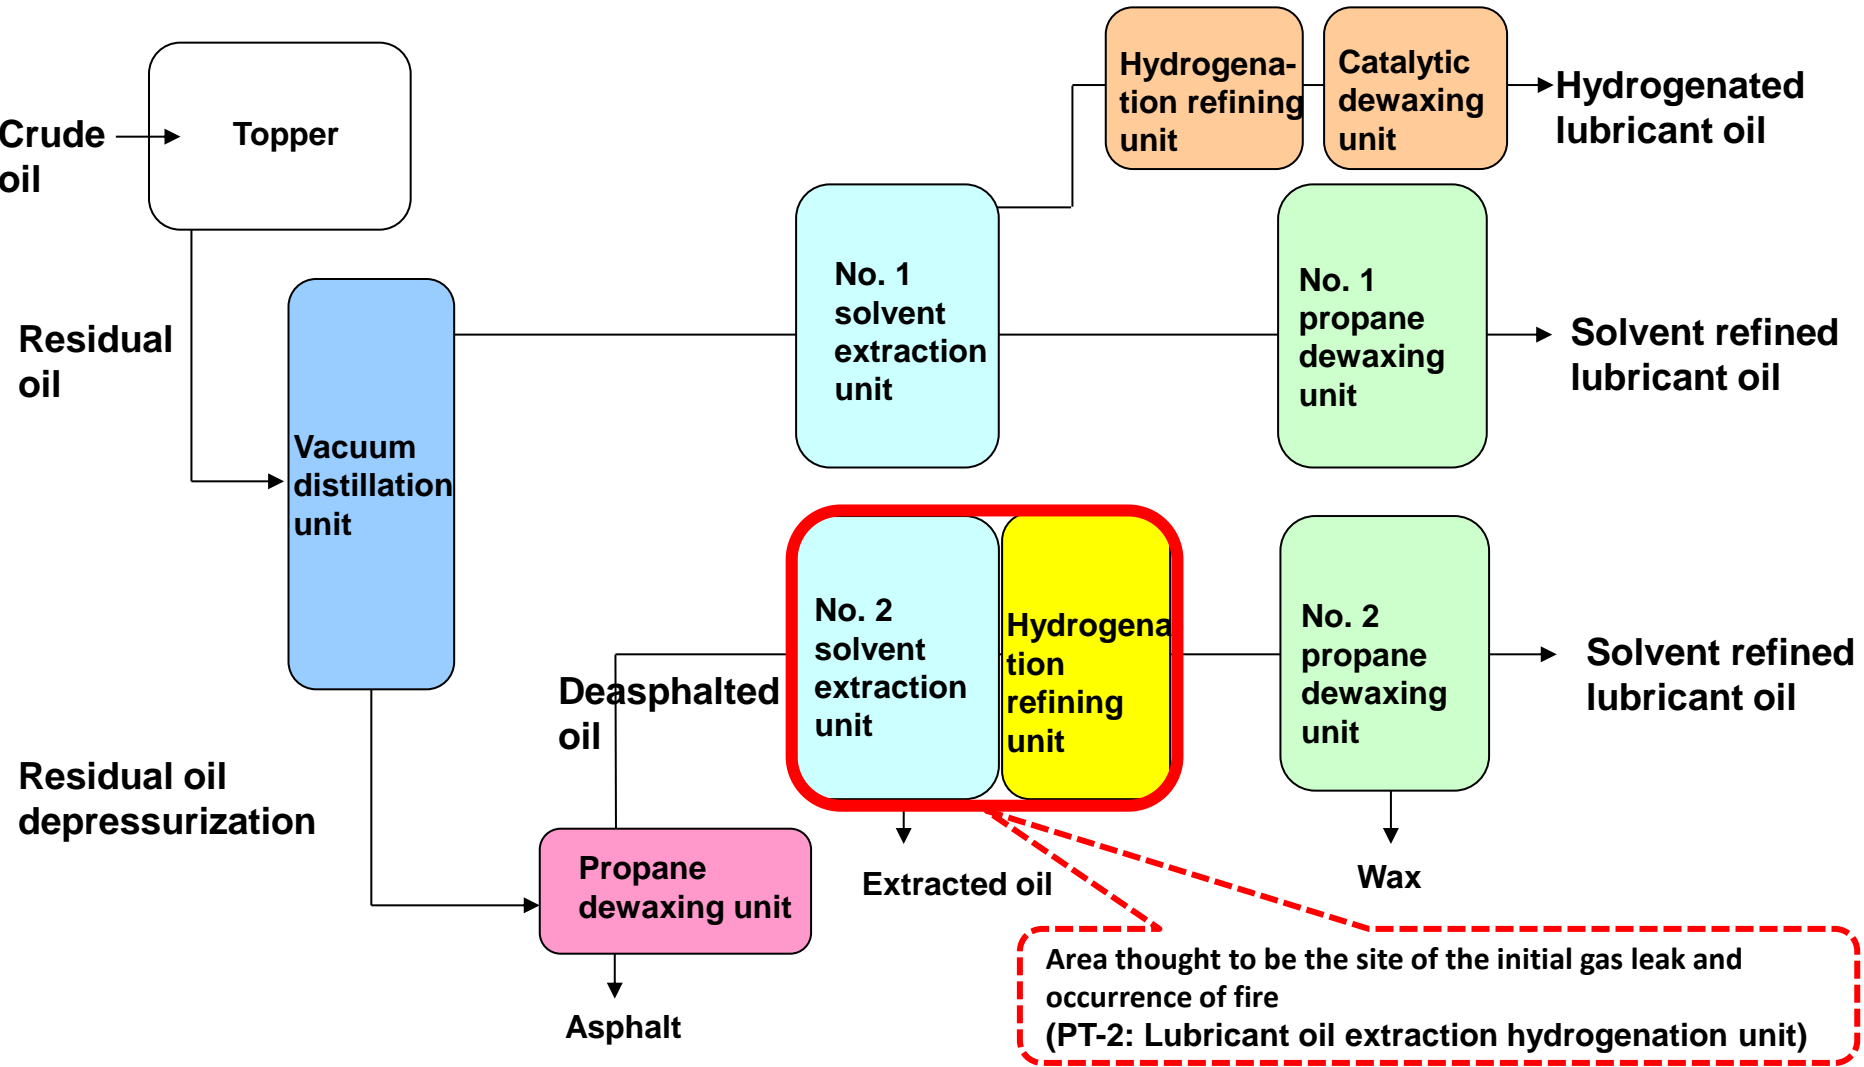
Supplemental diagram: Wakayama refinery lubricant oil refining process and area where fire occurred

- Results of site verification and investigation of operation records (operation data, alarm records, testimony of persons concerned, etc.) indicate possibility that a gas leak from the high-pressure purge gas system of the No. 2 lubricant oil extraction hydrogenation unit ignited the fire.

- Comprehensive identification and verification of assumed factors in malfunction of facilities in the affected area have begun. Twelve apertures and one flange malfunction, indicated by thickness of walls of facilities confirmed through X-rays, examination of surfaces of sections of pipes removed, and analysis of components of internal sediment in the pipes, have been identified as possible sites of the initial gas leak.

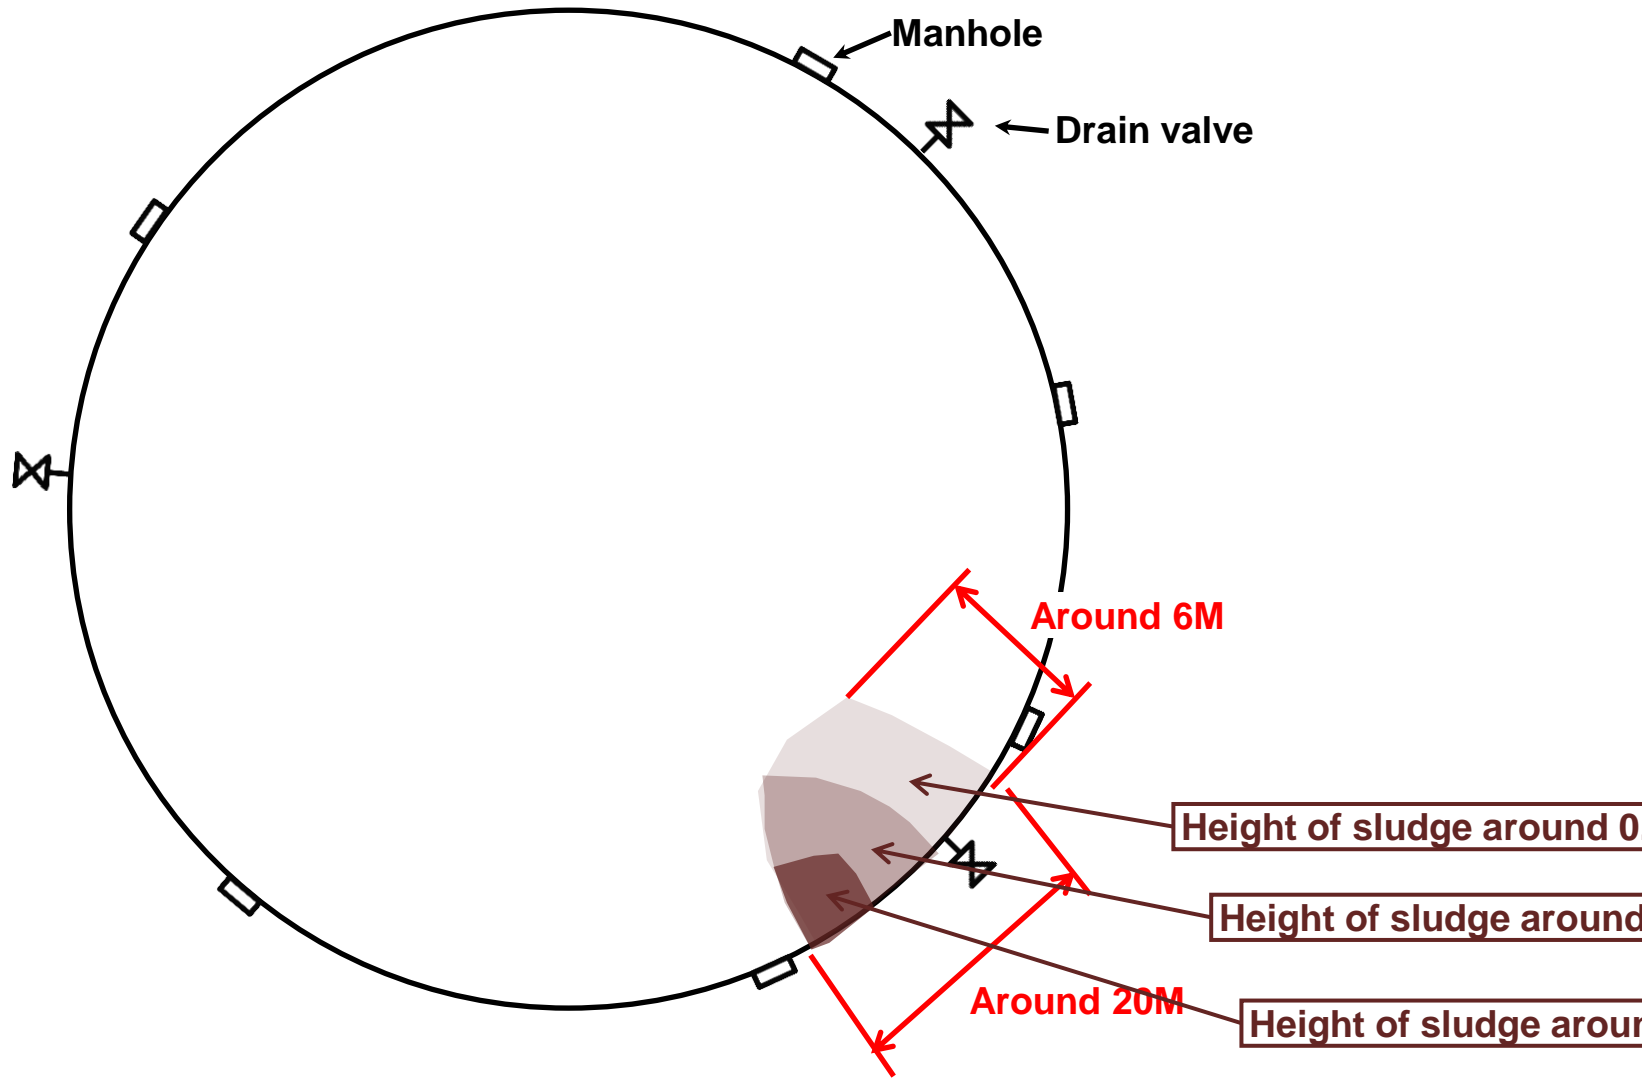
Supplemental diagram: Residual sludge in tank (before fire)

- As this was an internal tank fire that occurred in the absence of flames in the early morning during an interruption in sludge cleaning operations when no workers were around, possible flammable substances remaining in the tank (sludge, diesel used for dissolution, equipment, etc.) and sources of ignition (iron sulfide or other self-igniting substances, static electricity, lightning, heat from oxidation of oil soaked into rags, electric tools, arson, etc.) were investigated. In addition, results of analysis of sludge discharged from the tank indicate that when the sludge dries, it contains significant amounts of iron sulfide, a self-igniting substance. An ignition test of this sludge indicated that spontaneous combustion is possible.

- Judging from operation records and lists of materials used, the possibility of ignition factors other than iron sulfide is thought to be low, but final confirmation will be made at the time of on-site verification of tank interior.

- Final confirmation of ignition factors other than iron sulfide through the above on-site verification is incomplete, but specific procedures for countermeasures for ignition of iron sulfide will be incorporated into refinery regulations regarding countermeasures for ignition of iron sulfide in tank cleaning.
- In addition, awareness of risk of self-ignition of iron sulfide among employees and contractor company employees involved in tank cleaning will be raised, and training will be implemented to ensure compliance with specific procedures for countermeasures for ignition of iron sulfide.
